AN ANALYSIS OF MORTAR FROM THE ARCHEOLOGICAL SITE CARIČIN GRAD, SERBIA

ANA J. MOMČILOVIĆ-PETRONIJEVIĆ^{1*}, GORDANA A. TOPLIČIĆ-ĆURČIĆ¹, DUŠAN Z. GRDIĆ¹,
DRAGAN M. ĐORĐEVIĆ², NENAD S. RISTIĆ¹, ZORAN J. GRDIĆ¹

¹University of Nis, The Faculty of Civil Engineering and Architecture, Aleksandra Medvedeva 14, 18000 Nis, Serbia

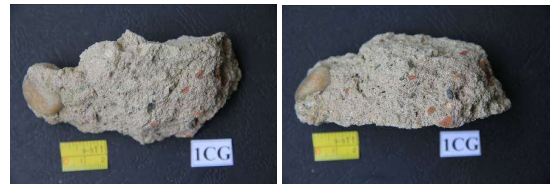
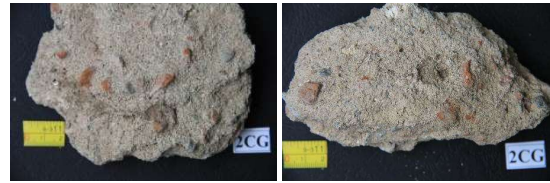
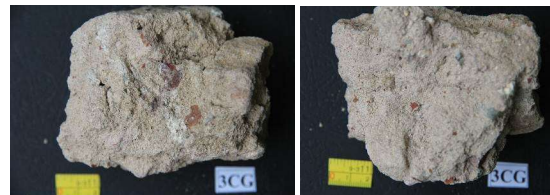
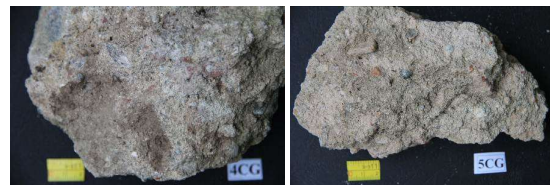
Fig. 3 - Original samples 1CG

Fig. 4 - Original samples 2CG

Fig. 5 - Original samples 3CG

Fig. 6 - Original samples 4CG and 5CG

The samples were labelled from 1CG to 5CG. The photographs from the number 3 to 6 present the appearance of the original samples and the photographs 7 and 8 present their flat section. As it can be seen in the photos, all the samples are fairly compact, but with clearly visible grains of the river aggregate, a large number of masonry brick chips and limestone aggregate grains are visible, but in traces (this can be seen in SEM analyses which will be presented later).

The color of the mortar samples indicates that lime was used only as randomly present binder. Pulverizing the bricks activated the pozzolanic activity, and this achieved that this powdery material was used as the main binder in the mortar. Since the mortar also contains the grains of crushed limestone aggregate,

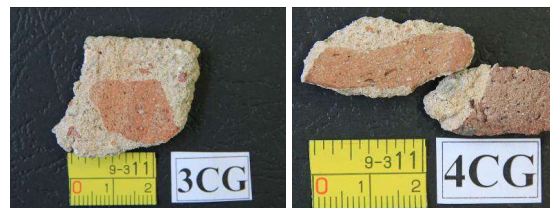
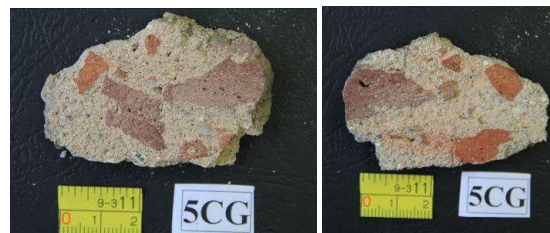
Fig. 7 - Appearance of 3CG and 4CG samples flat sections

Fig. 8 - Appearance of 5CG samples flat sections

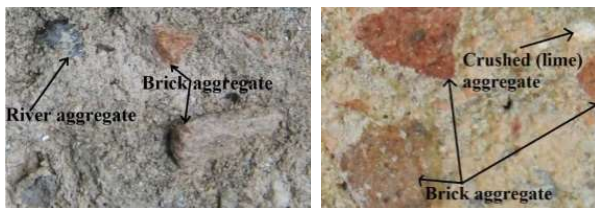
Fig. 9 - Sample detail 1CG (left) and 2CG (right)

Fig. 10 - Sample detail 2CG (left) and sample flat section surface detail 3CG (right)

Fig. 11 - Sample detail 4CG (left) and sample flat section surface detail 4CG (right)

Fig. 12 - Sample detail 5CG (left) and sample flat section surface detail 5CG (right)

In order to acquire more data on the composition of the tested mortar samples, microscopic photos were taken. For this purpose stereo zoom microscope with larger magnifications was used. Magnifications ranged from x100 to x280. Some of those are the photos in Figures 9 through 12.

Microscopic investigation of samples in Figures 9 and 12, led to the conclusion that mortar contained river aggregate in all samples, crushed aggregate, as well as limestone aggregate. River aggregate prevailed, followed by crushed masonry blocks and limestone aggregate. There were traces of other crushed aggregates.

The photographs showed that all samples had multiple pores and cavities.

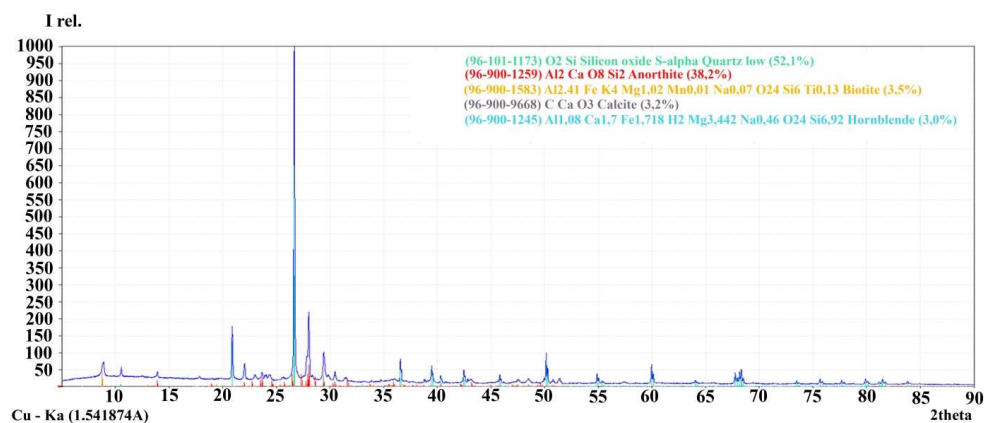
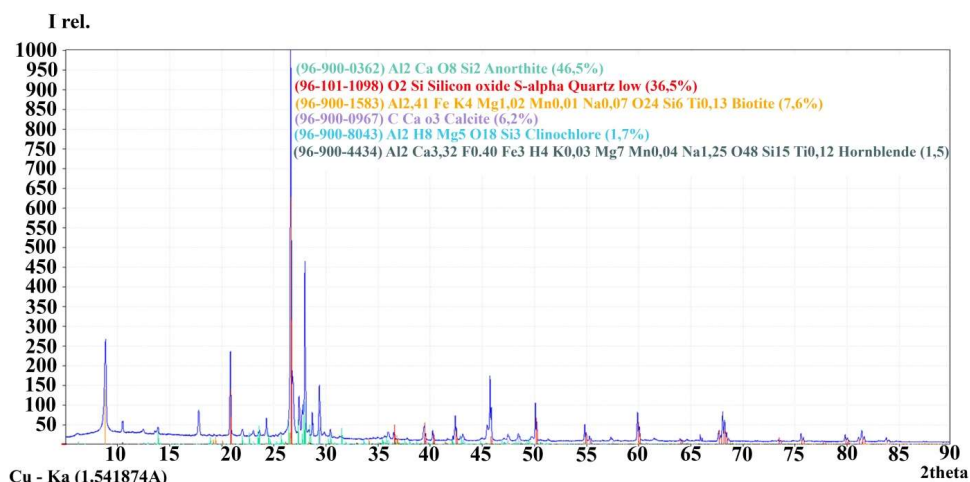
Fig. 13 - XRD spectrum 1CG

Fig. 14 - XRD spectrum 2CG

Fig. 15 - XRD spectrum 3CG

Fig. 16 - XRD spectrum 4CG

Fig. 17 - XRD spectrum 5CG

In the tested samples, apart from the prevailing quartz mineral (from 37 % to almost 60 %), there is a lot of anorthite (from 27 % to 47 wt%), and a smaller quantity of calcite (4 % to 7wt%) and biotite (3% to 8 wt %). This indicates that for making of the mortar, the river aggregate was used in the most part (presence of anorthite), and crushed limestone aggregate (calcite and biotite). The presence of calcite in the mentioned percentage suggests the usage of the pulverized brick as a pozzolanic material.

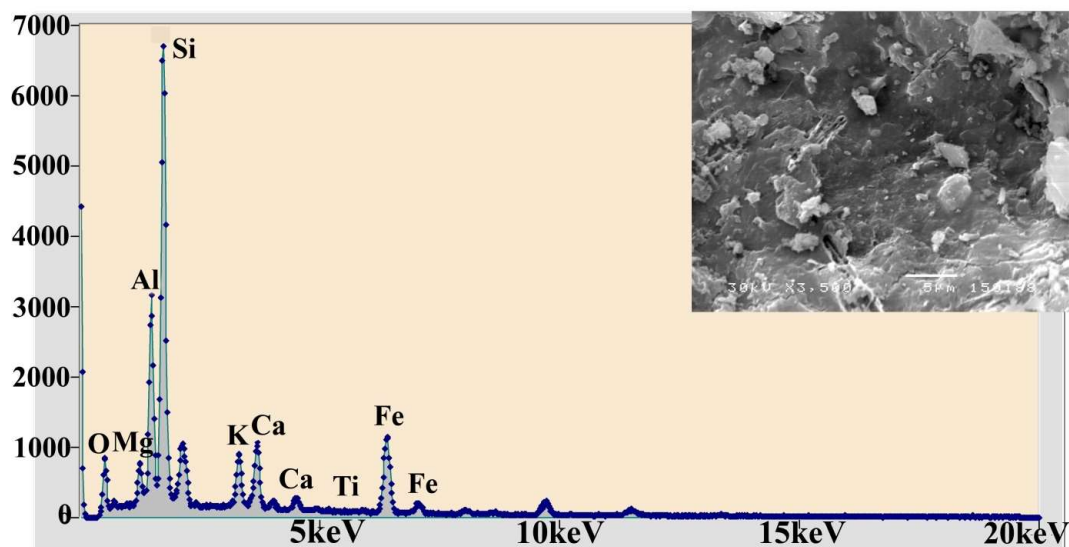
Fig. 18 - Sample 1CG - SEM micrograph and EDS spectra

SEM/EDS analysis showed the same as XRD and XRF analysis. Therefore, the previously obtained results are confirmed in this way. The 1CG sample is for the most part made from

Si and Al, with the presence of Ca and Fe (Figure18). This is confirmed by the XRD data showing that this sample was mainly made of quartz and anorthite with traces of calcite and biotite, i.e. together with XRF from which one can conclude that the sample consisted of oxides of Si and Al (SiO_2 and Al_2O_3) with some compounds with Ca and Fe.

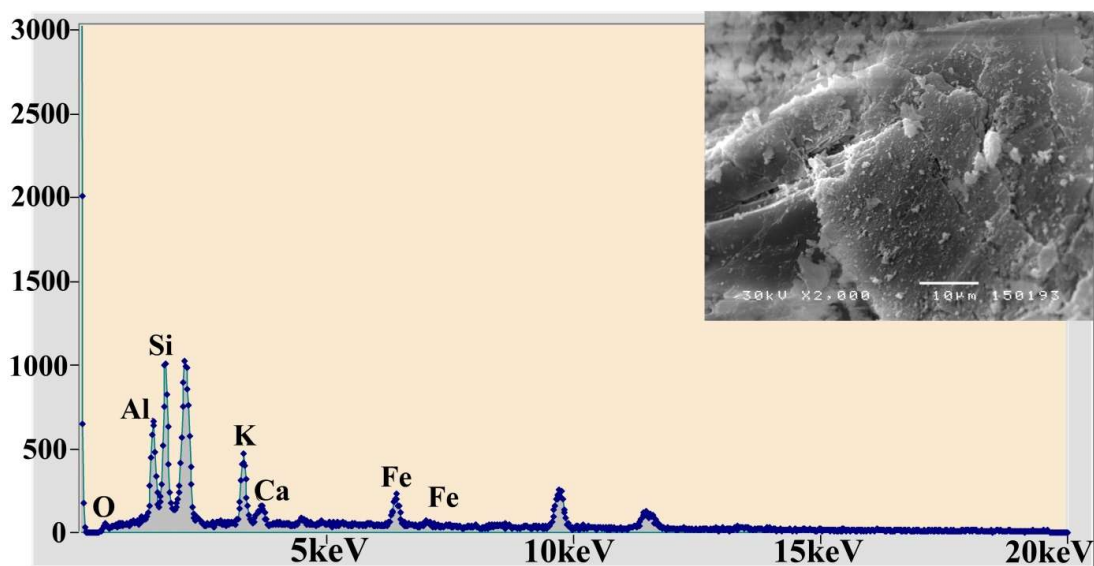
Fig. 20 - Sample 3CG - SEM micrograph and EDS spectra

The EDS spectrum of 3CG sample, (Figure20) showed approximately the same contents of Si and Al, with little Ca. It can be assumed that this SEM photograph, i.e. EDS spectrum corresponded to anorthite, considering its formula ($\text{CaAl}_2\text{Si}_2\text{O}_8$). This is in full agreement

with the XRD analysis which confirmed that there was over 40% of this mineral in the sample 3CG.

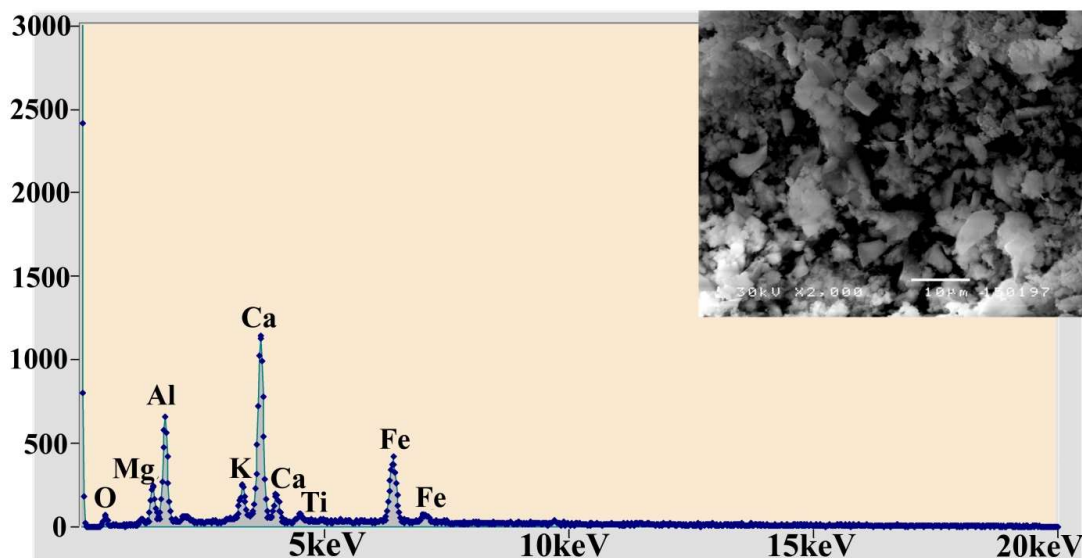
Fig. 21 - Sample 4CG - SEM micrograph and EDS spectra

In the EDS spectrum of the sample 4CG, Figure 21, bands of Ca, Al and Fe were dominant. The absence of the Si band was interesting. This indicated that in the SEM photograph some Fe mineral, i.e. biotite or hornblende was which was not unexpected, because these minerals were mostly present in this sample. Finally, there is the SEM/EDS of the sample 5 CG, Figure 22. There, the EDS spectrum mostly shows bands of Si, Ca and also Al as well as the presence of Fe which is all in agreement with the obtained results of XRD and XRF analyses. All this confirms the assumption that aggregate in the samples examined was river aggregate, brick fragments and limestone crushed aggregate.
