Noise Protected Buildings

This paper presents the example of activities to protect occupants from the noise. The analysis was made in case when the boiler for heating of the building and the surrounding colony is settled in the basement of the building. As has often been the case earlier in the design of new settlements heating boilers were housed in the annex building or basement area. As the colony grow, the changes were made in the technology of heating and to increase of heating capacity. Accordingly, there came deterioration of conditions in terms of noise in apartments. In our example, we analyzed primary and secondary sources of noise and their impact on the occupants in the building. On the basis of the analysis of noise levels and insulating capabilities of the walls and ceilings the measures for noise reduction are proposed. Combined methods of active and passive noise abatement measures have been applied in phases in order to achieve a satisfactory level of noise in the most affected dwellings. The paper also presents some results, achieved improvements, derived measures of protection against noise.

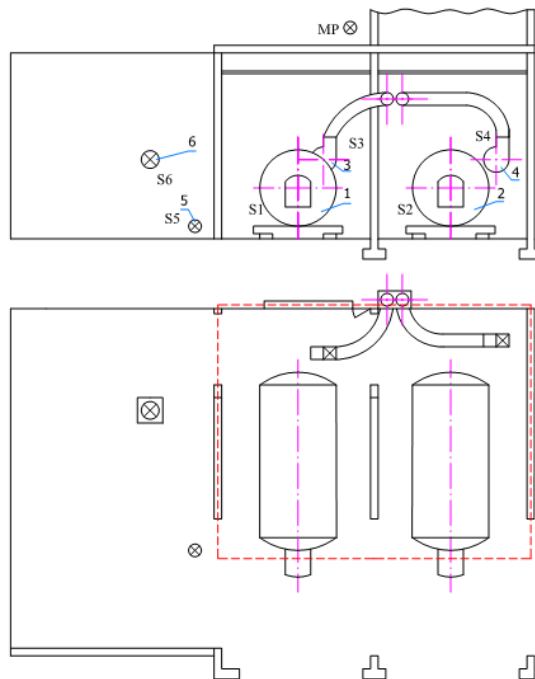
Fig.1. Layout of boiler room

1- boiler No. 1; 2 – boiler No. 2; 3 – flue gas fan (No.1); 4 - flue gas fan (No.2); 5 – pump to maintain pressure; 6 – circulation pump

The disadvantage of this layout is that the loudest devices are just below the apartments. The chimney is physically located in the center of the building so that the sound generated from the oil burning in furnace and the operating fan transfers into the building as airborne sound and the second part as structural sound. Figure 1. shows the layout of equipment and position of the nearest apartment.

Circulation pump item.6 located in room 2.(Left to the boilers room) has relatively the same effect on noise in the hallway as boilers, because it is structurally connected to the ceiling and the insulation between the room and hall is much weaker. In this case there is a transfer of airborne and structural noise. Structural noise is transmitted through the pipe and support structure.

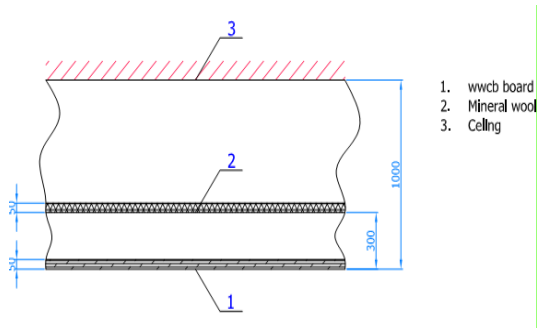
Fig.3 Suspended ceiling

After setting up sound insulation area the access to the sealing must be implemented in order to reduce the impact of airborne sound influence on ceiling which is also under the nearest dwelling. Suspended ceiling is made in combination of wwcB board and layer of mineral wool in the distances given by Fig.3

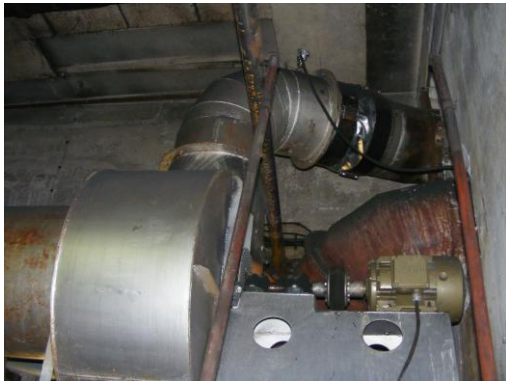
Fig 4. An example of flexible connection

Equipment like boilers, fans, engines, pipes and pumps were fixed on walls and ceiling. This fixing method enables directing the sound and vibration transmission through the construction of the building structure which is far less favorable to tenants in respect of air sound. Therefore, wherever possible it is necessary to physically separate the supporting mechanical structure of these devices from the walls and ceiling. Our supporting structure is fixed to the floor by elastic stands. In cases where it is not

possible, rigid connection is to be replaced by an elastic one. In Figures 4,5,6 the examples of such interventions are given.

Circulation pumps and their motors located in room 2. were isolated by the designed enclosures, filled with absorbent material and ventilation directed to the floor. Thus the noise

emission was prevented directly towards the ceiling and apartments in the building (see Fig.4).

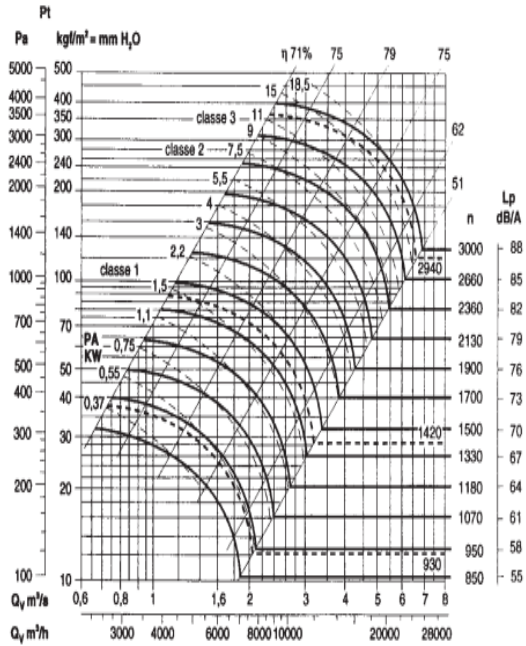
Fig.7 Fan working diagrams

When considering the parameters through which one can define the optimal mode of the fan, then these are: type of ventilators, installed capacity, speed, pressure, strain, number of blades, correction and form of adapter on duct. It is clear that the basic requirement to satisfy capacity and pressure. Manufacturers provide the fan working diagrams Fig.6.showing that the reduction of speed is a manner to get the optimal capacity. As is common to the design capacity of the fan system is oversized, it is clear that the reduction in speed can make quieter operation noise of fan. It can be achieved in real terms and up to 15dB.

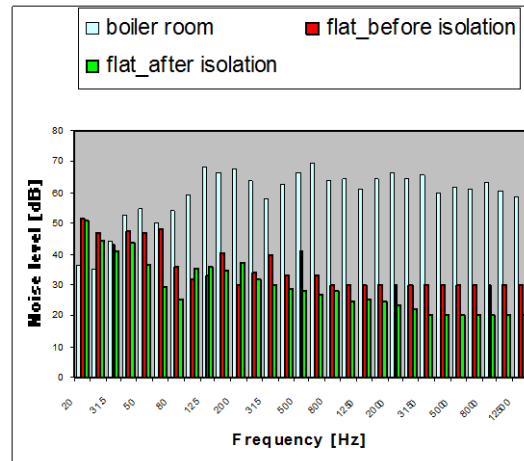
Fig.8 1/3 octave band frequency diagram

After the completion of construction and mechanical work, measuring of the reduction of noise levels has been done. It is shown in Fig.7. The measuring was done in 1 / 3 octave band frequency domain and it is evident that there is a significant reduction in noise levels.

Total reduction of noise level for the first two activities is at the level of 6dBA. As the measurement was carried out in the hallway between the apartments it is realistic to expect that effective reduction is 10dBA because there is an additional insulation in the apartment such as flooring and carpets.
